Figure A-13
Site-Wide Soil Sampling Results for
Soil Gas Alternatives: Naphthalene
Riverside Industrial Park Superfund Site
Essex County, New Jersey

Site-Wide Soil Gas Sampling Results for Soil Gas Alternatives: Xylenes (Total)

Riverside Industrial Park Superfund Site

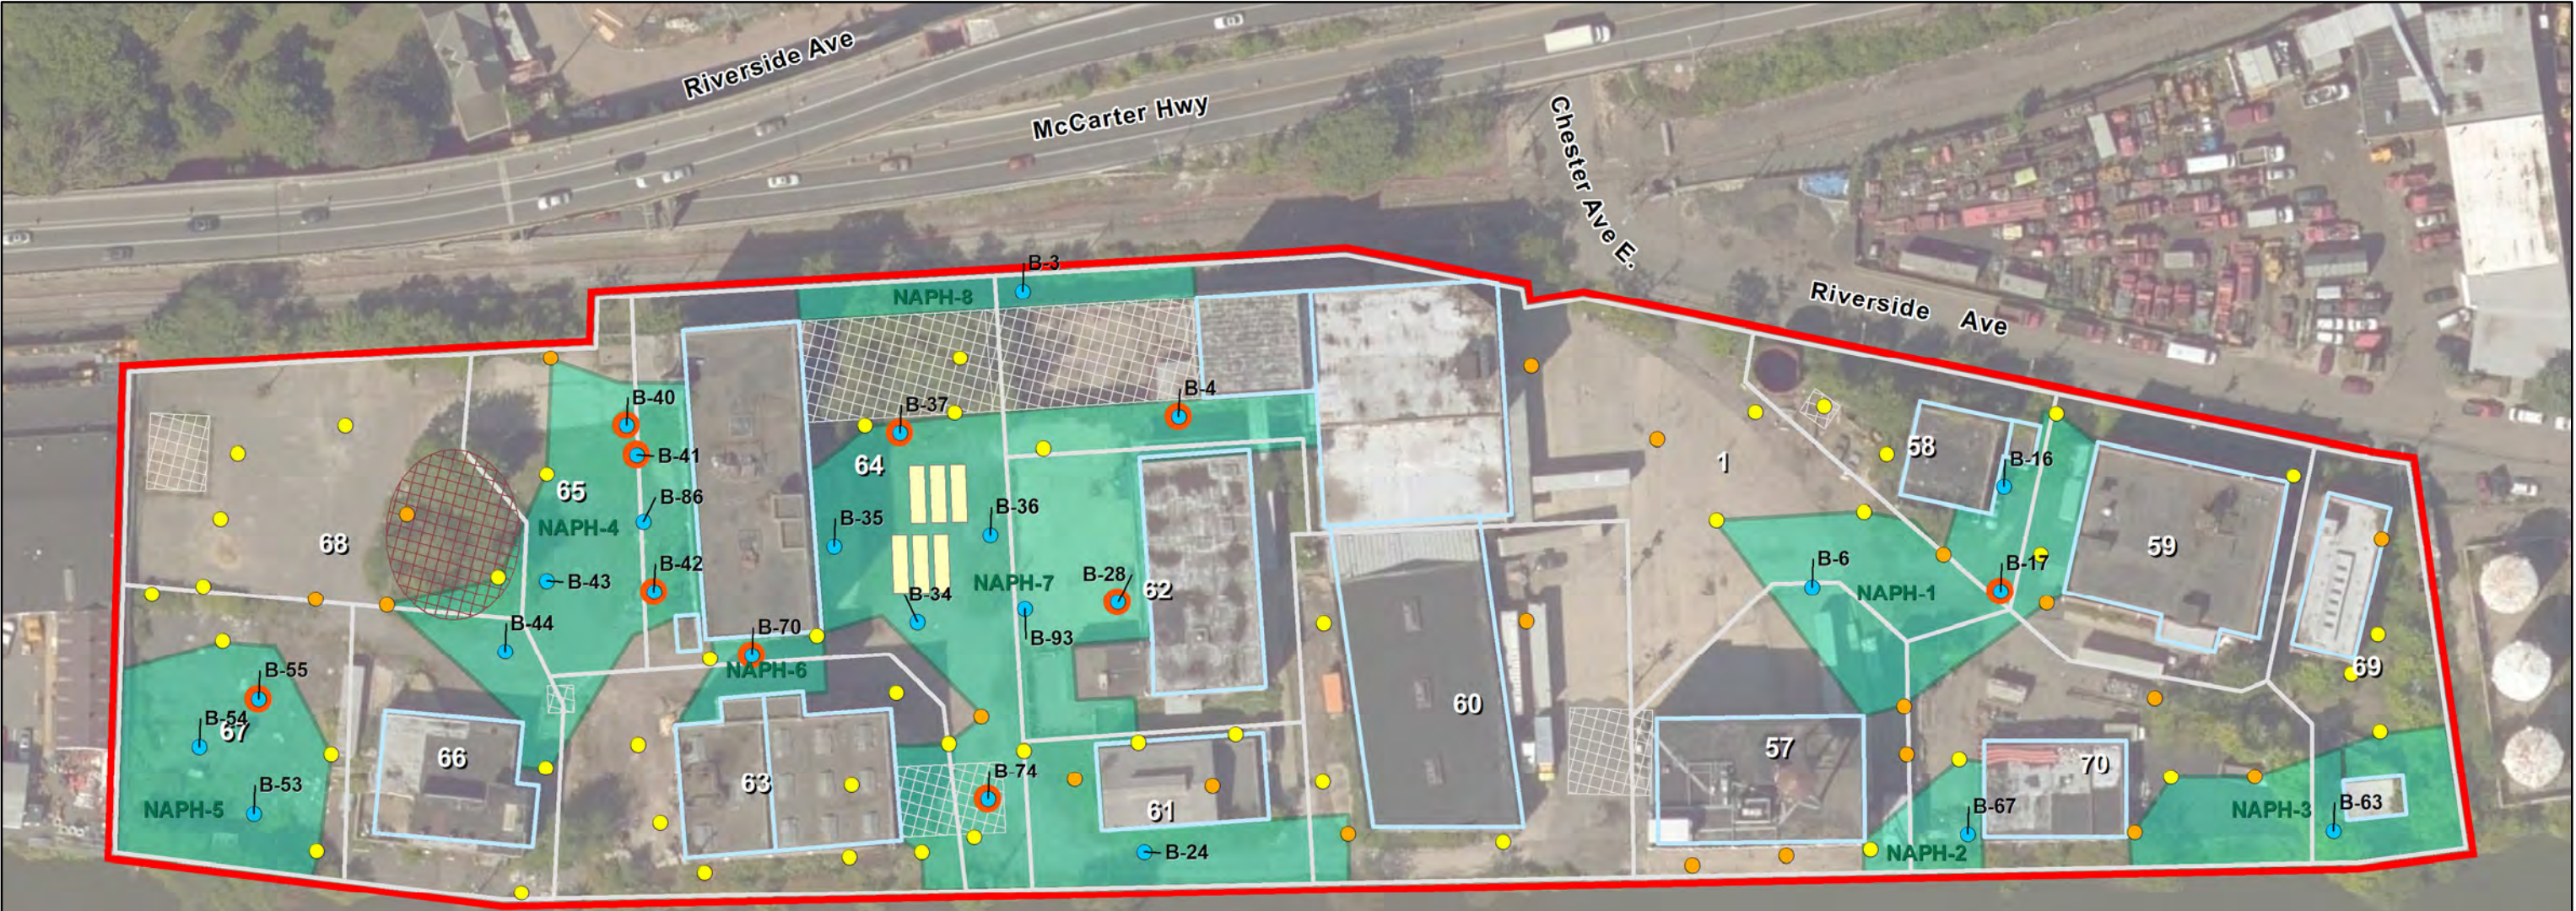
Area	SqFt	Acres
NAPH-1	13671.79	0.31
NAPH-2	2527.79	0.06
NAPH-3	8077.46	0.19
NAPH-4	16078.80	0.37
NAPH-5	11021.63	0.25
NAPH-6	2077.04	0.05
NAPH-7	37278.79	0.86
NAPH-8	3687.50	0.08

Notes:
1. Field Duplicate and Parent Sample Concentrations were averaged.
2. Following the soil mound removal on lot 68, surface samples at locations B-59 and B-60 were not included in this evaluation.

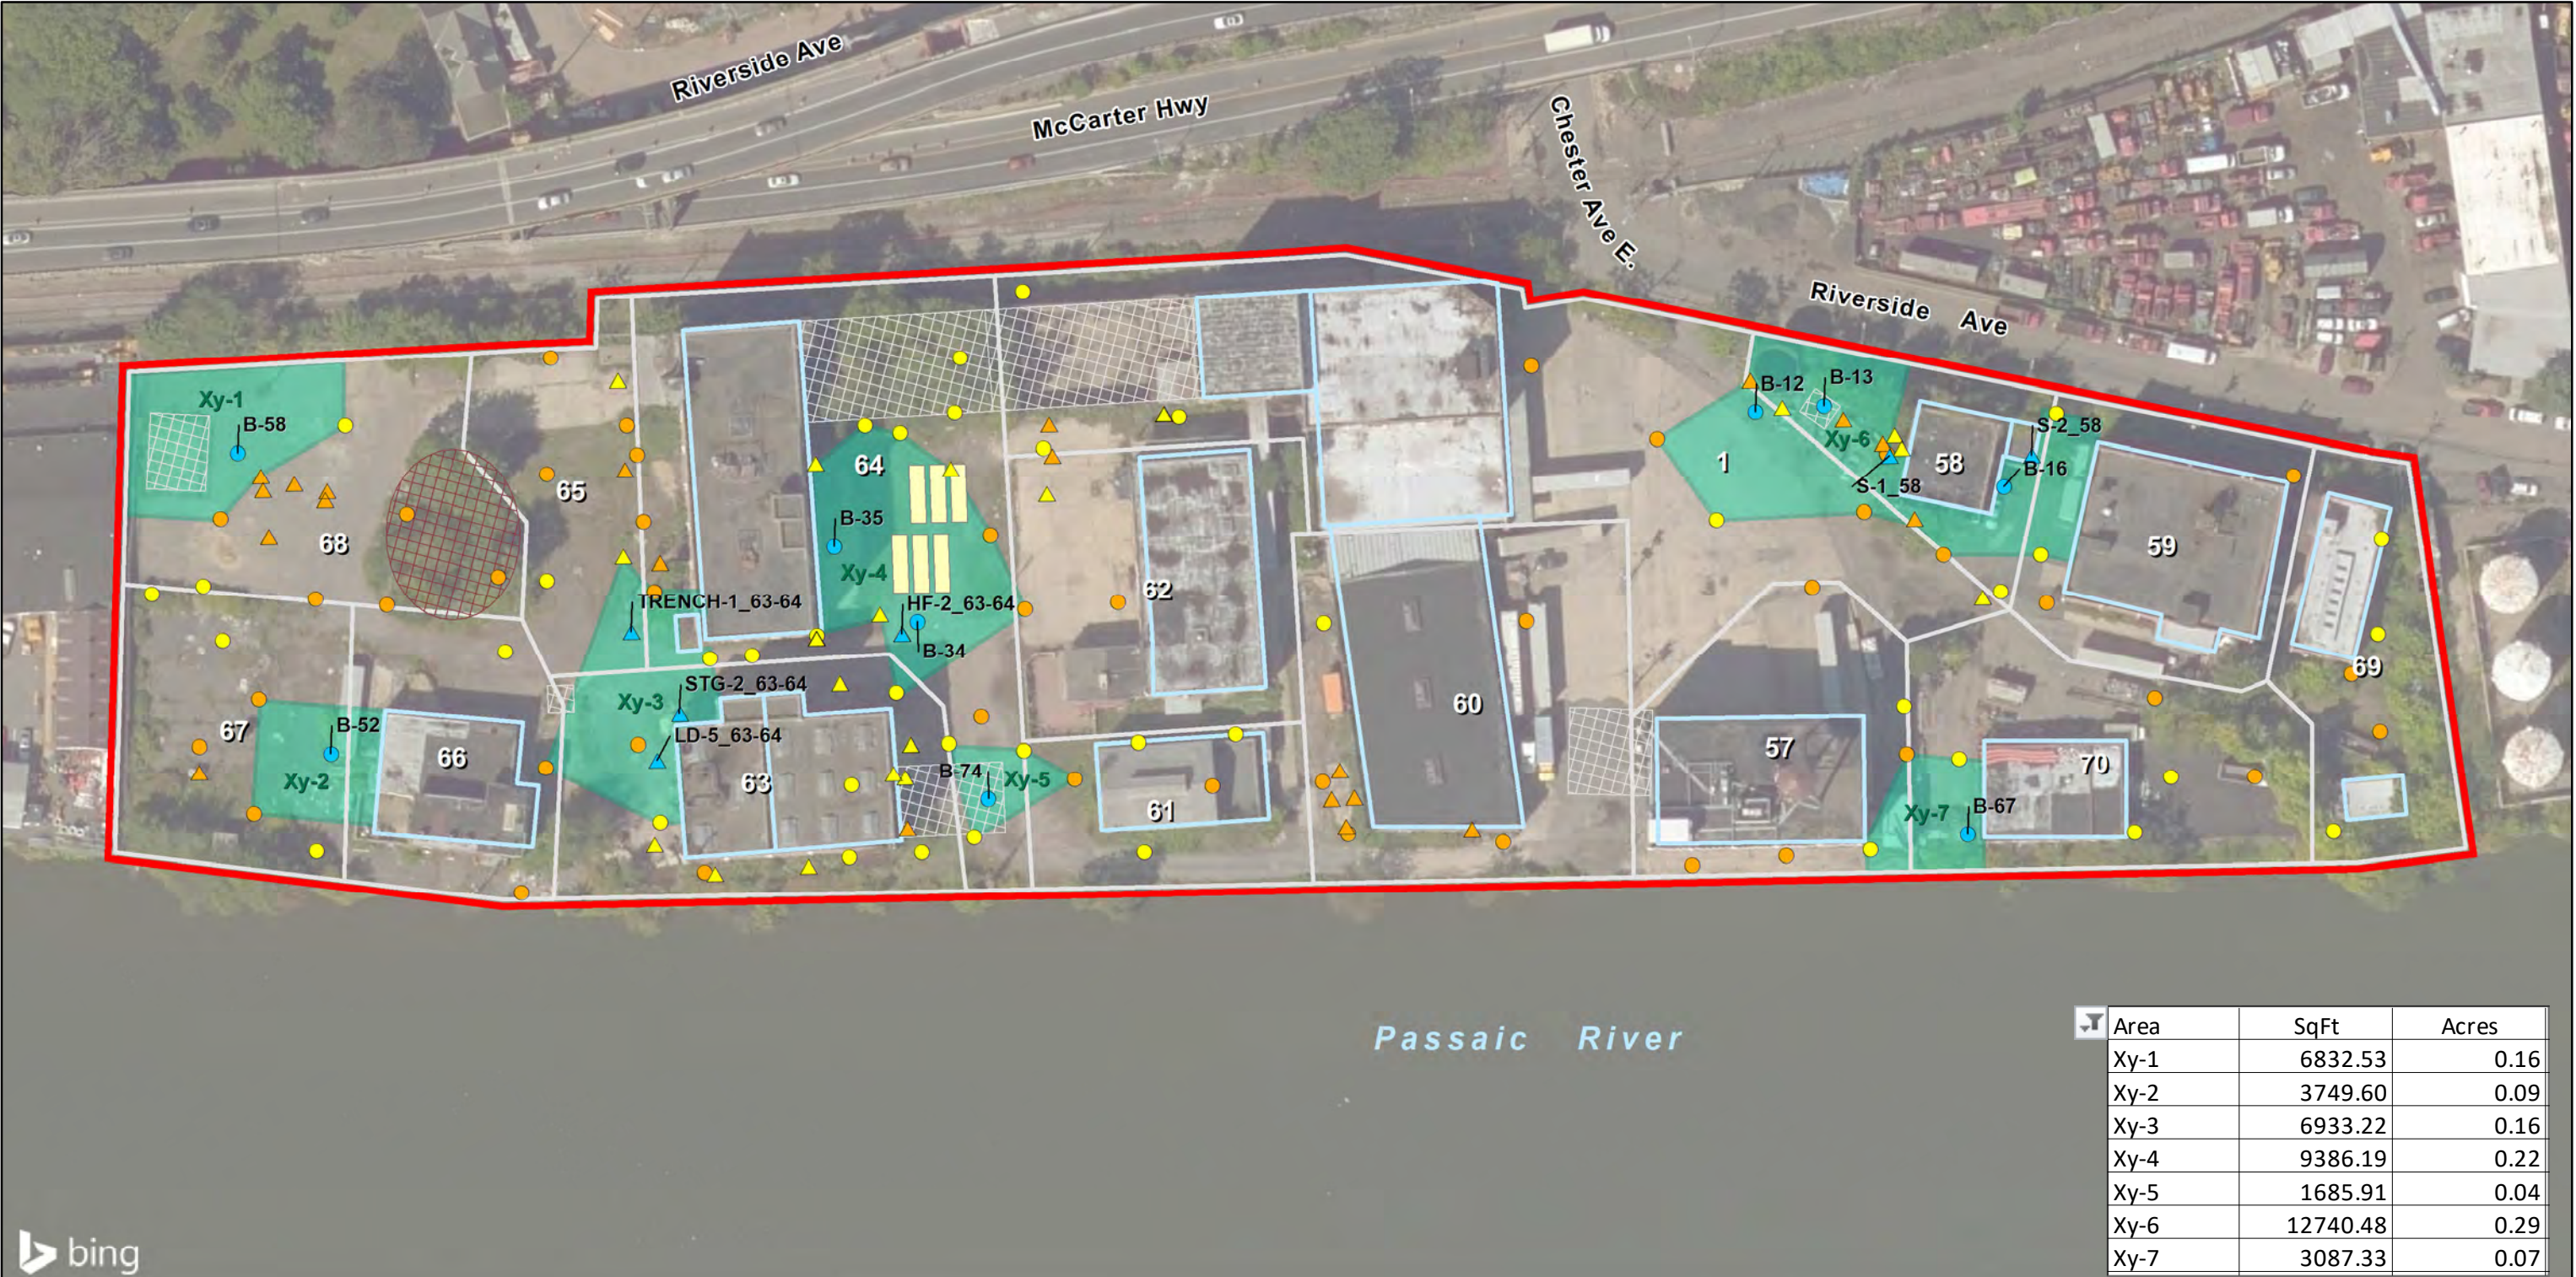
Figure A-15

Notes:
1. Field Duplicate and Parent Sample Concentrations were averaged.
2. Following the soil mound removal on lot 68, surface samples at locations B-59 and B-60 were not included in this evaluation.
3. Total Xylenes calculation is consistent with the BHHRA.
